Manhole Inspection Summary

Manhole # S57G__010MH

Insp Date: **1/2/09 9:31 AM**

Location Address: **rear 3901 e pratt st**

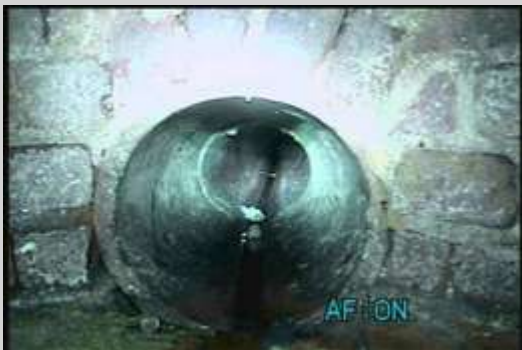
12 O'Clock Outflow

8 in. Circular Gravity Sewer
Pipe Out @ 12 O'Clock

Pipe Material: **Clay** ☐ Pipe Lined

Invert Depth: 5.41 (ft.) Flow Characteristics: **None**

Deposits: ☒ None ☐ Mud ☐ Sludge ☐ Debris ☐ Grease

Infiltration: **None** Pipe Seal Cond: **Unknown**

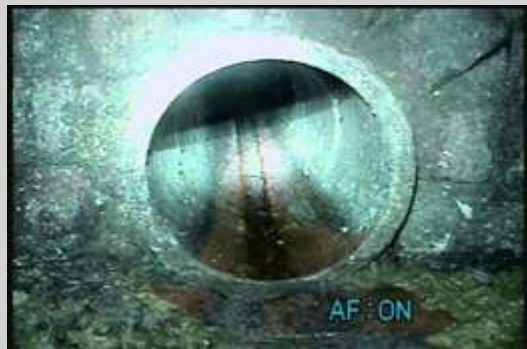
9 O'Clock Inflow

8 in. Circular Gravity Sewer
Pipe In @ 9 O'Clock

Pipe Material: Clay ☐ Pipe Lined

Infiltration: None
